# Upper Pecos Watershed Based Plan

Submitted to the New  
Mexico Environment  
Department

by:  
**The Upper Pecos  
Watershed Association**

Revised:  
**February 2019**

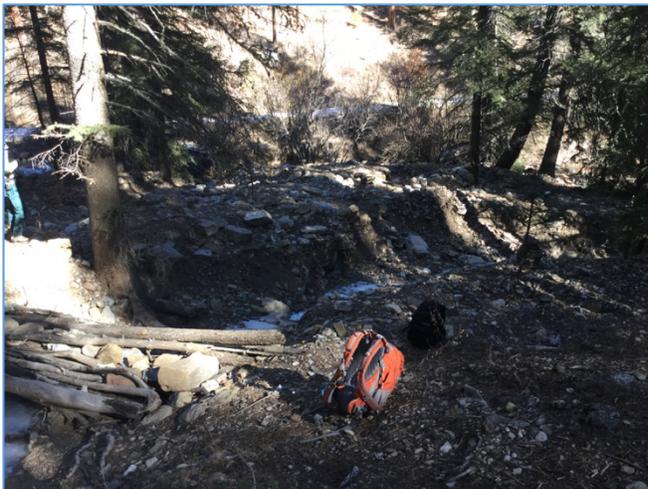
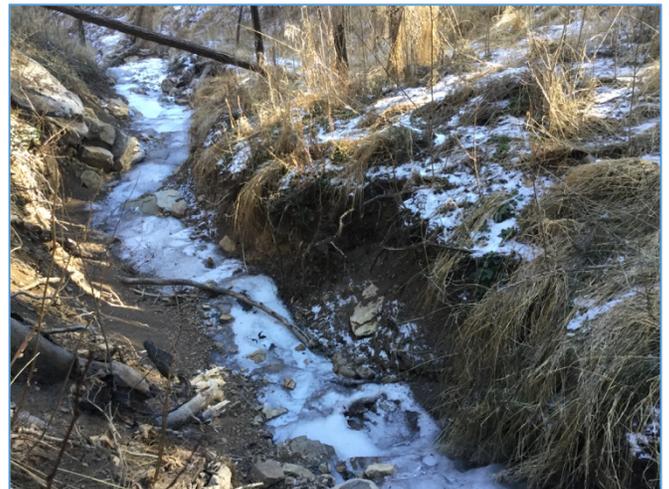
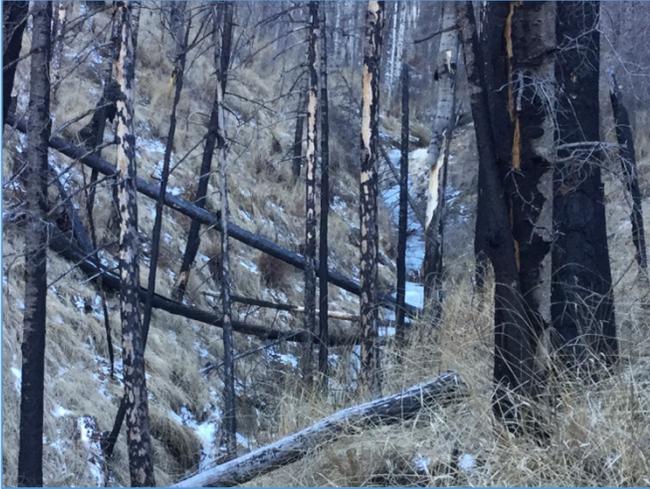
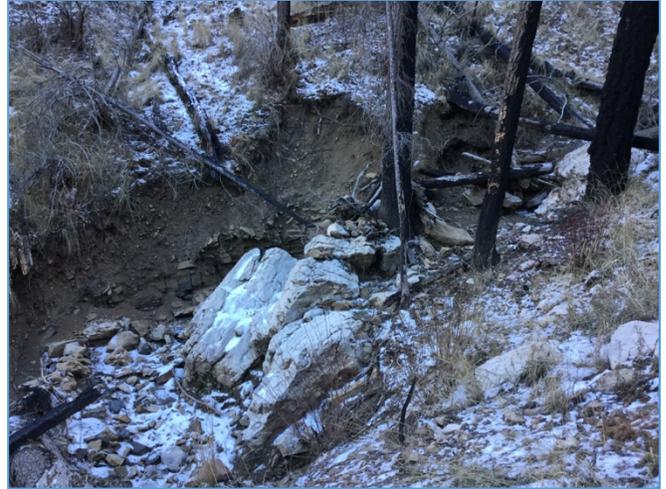
In a report prepared for the Tres Lagunas Fire, the US Forest Service Burned Area Emergency Response (BAER) Team predicted from 2.5 to 11 times normal erosion and runoff in the burned areas under an average 25-year rain storm event (USFS 2013). Heavy precipitation in the immediate post-fire period resulted in severe erosion and flooding in and below both burn areas. Soldier Creek in the Cow Creek basin was one of the hardest hit. Flood and fire damage to the creek and tributary drainages in Holy Ghost Canyon is shown in the photographs below.

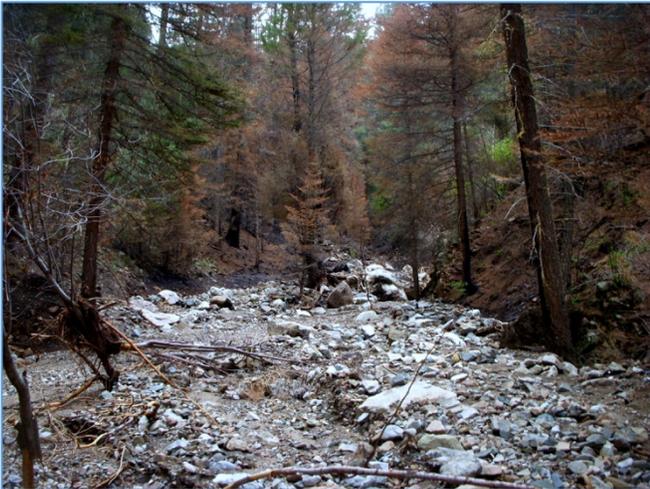
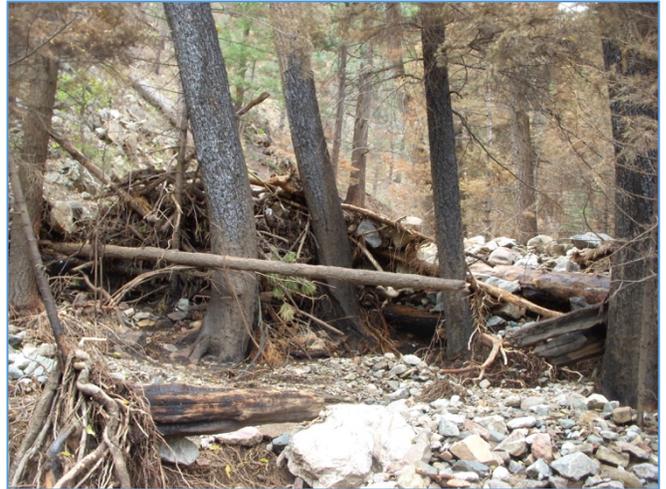
The following photographs were taken in the aftermath of the Tres Lagunas Fire of an unnamed tributary drainage to the Pecos River located on the east side of the river approximately 0.86 mile south of Tererro.

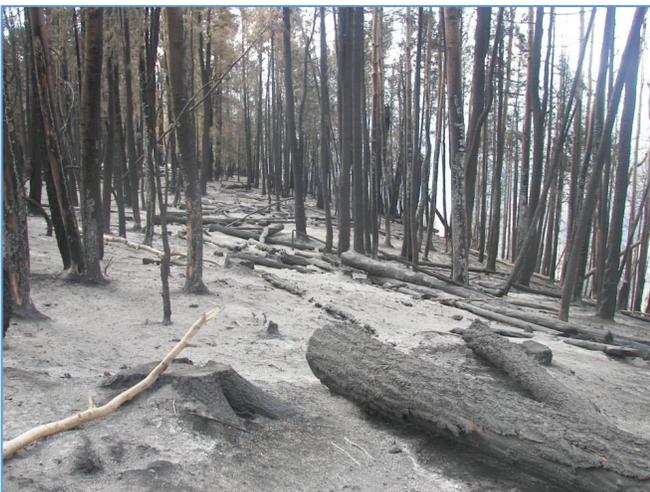
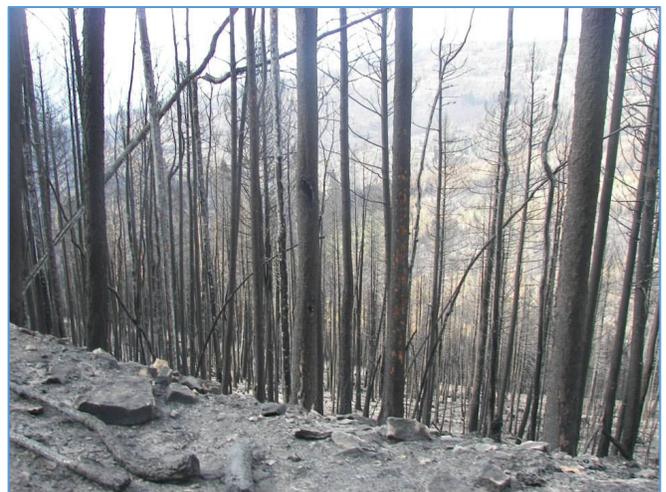
The following two photographs were taken near Viveash Mesa in the aftermath of the Tres Lagunas Fire.

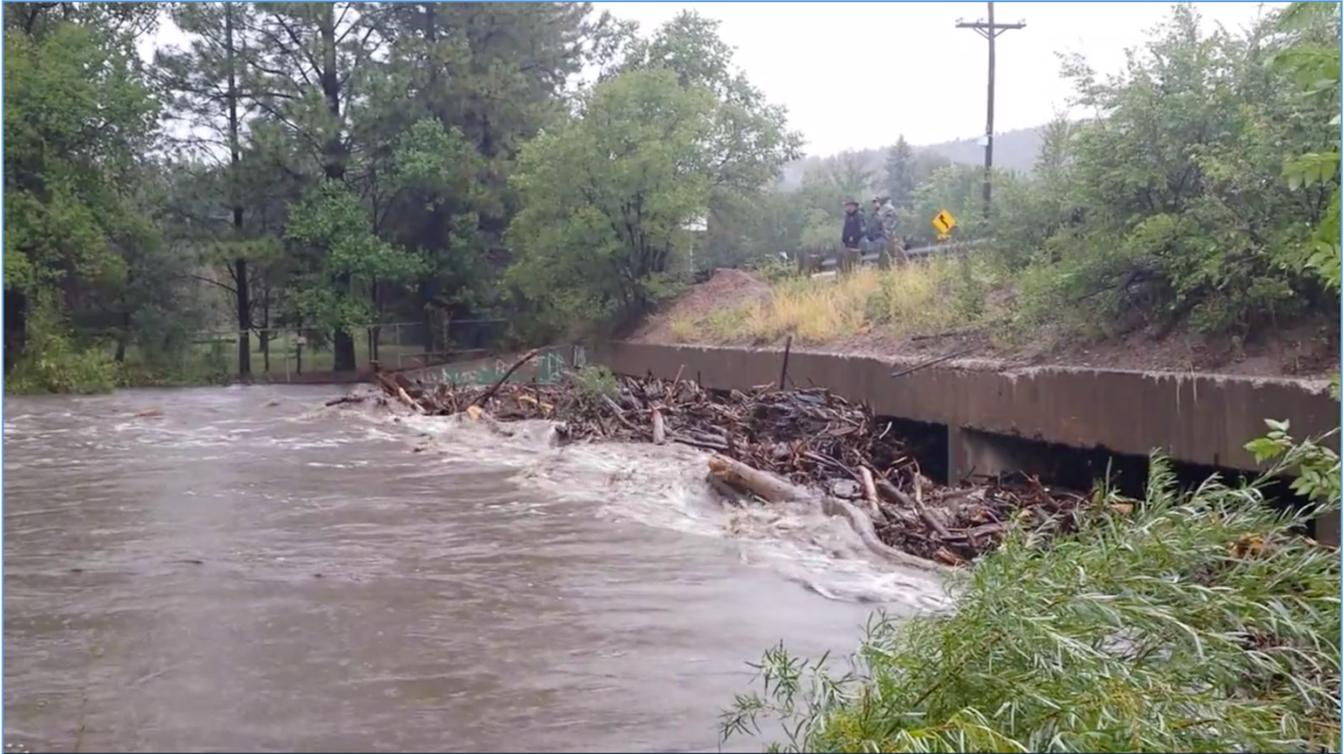
The following photograph was extracted from the video on the UPWA Facebook page.

The long-term observable effects of the post-fire flooding were bank erosion, loss of floodplains, entrenchment, and a broad, shallow channel with few or no deep pools. Recovery from these fires has been very slow and primarily manifested in the form of revegetation. In the immediate aftermath of the fire, steep slopes were aerial seeded with barley (*Hordeum vulgare*), little bluestem (*Schizachyrium scoparium*), muttongrass (*Poa fendleriana*), and slender wheatgrass (*Elymus trachycaulus*) in an effort to minimize the severity of anticipated erosion. Five years later, the dominant species in the herbaceous layer on the upper slopes of Holy Ghost Canyon continues to be slender wheatgrass. Native herbaceous species are not returning quickly.

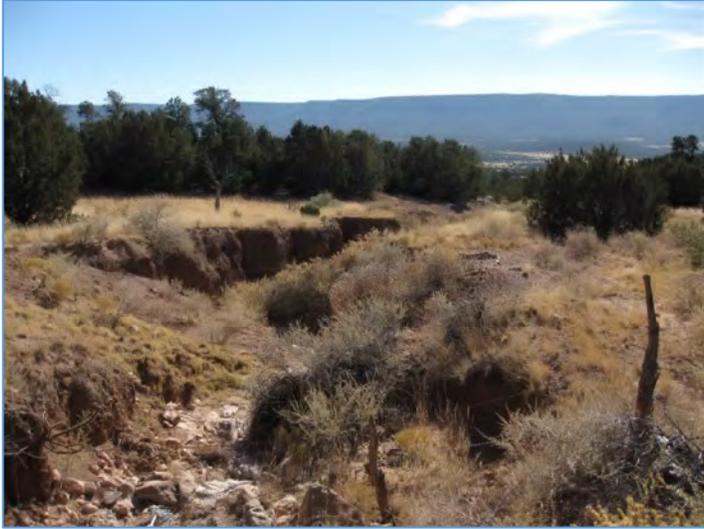
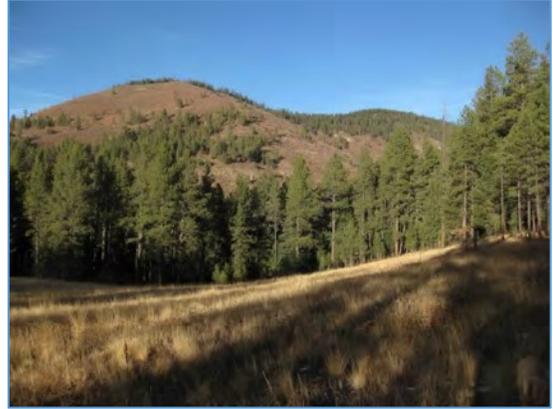
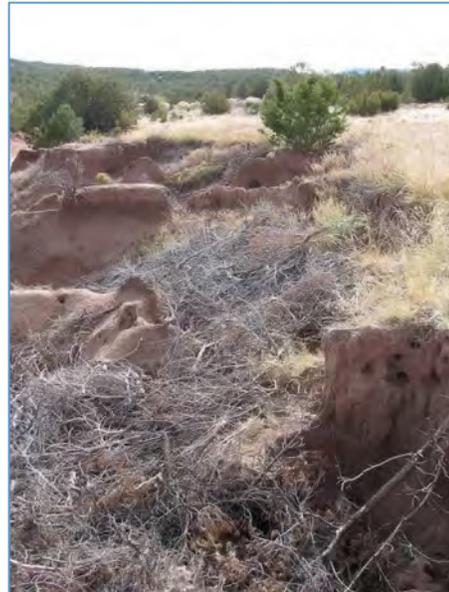
*Typical sediment class landforms in the upper Pecos Foothills (above), mountain (upper right), and xeric (lower right).*

A 2010 study by Tetra-Tech, Inc. (funded by the New Mexico Environment Department and EPA) analyzed data on both streambed and suspended sediment in a large sample of streams in New Mexico, eastern Arizona, and southern Colorado in relation to both disturbance patterns and geographical location. The focus of the study was to evaluate and suggest potential numerical sediment levels that would be valid indicators of disturbance or lack of it in New Mexico streams. These suggestions of sediment levels (percentages of different size classes of stream bottom sediment) are preliminary and have no regulatory status, but one significant finding of the study is that the percentages of sediment size classes present in relatively undisturbed streams is quite different in different geographical zones, based primarily on altitude and topography (with associated differences in vegetation types). In terms of expected background sediment transport levels in streams, the study found three relevant geographic or land-form types within New Mexico: mountain, foothill, and xeric zones.

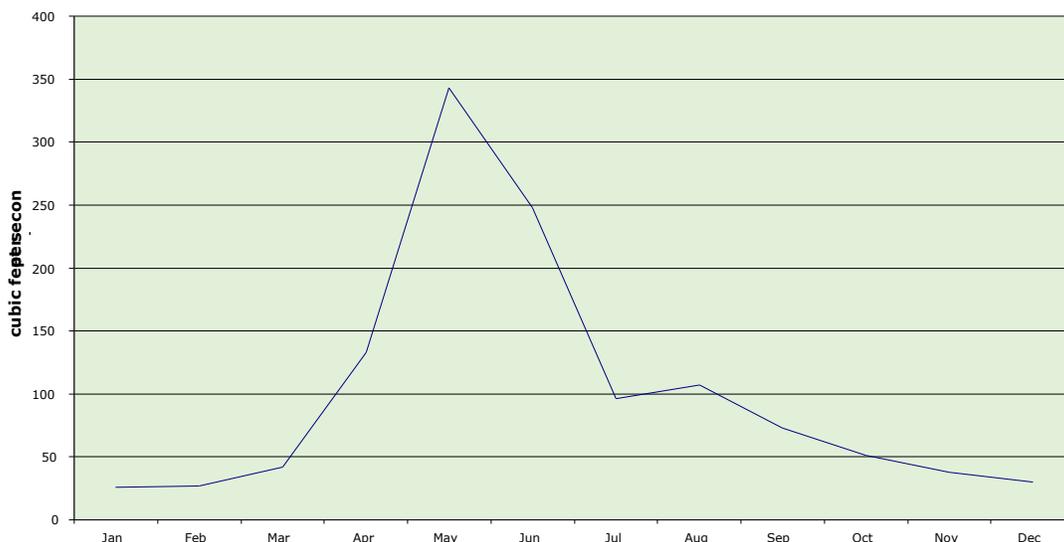
**Pecos River near Pecos - Monthly Average Flows**

The flow regimes for both stream types are dominated by springtime snowmelt runoff, followed by smaller, more localized, and more unpredictable secondary rises during the summer monsoons. The average flow rates for the Pecos River at the USGS gauging station near the Village of Pecos are shown in the graph below, while the major tributaries and sub watersheds of the upper Pecos are shown on the map on Page 2 above.

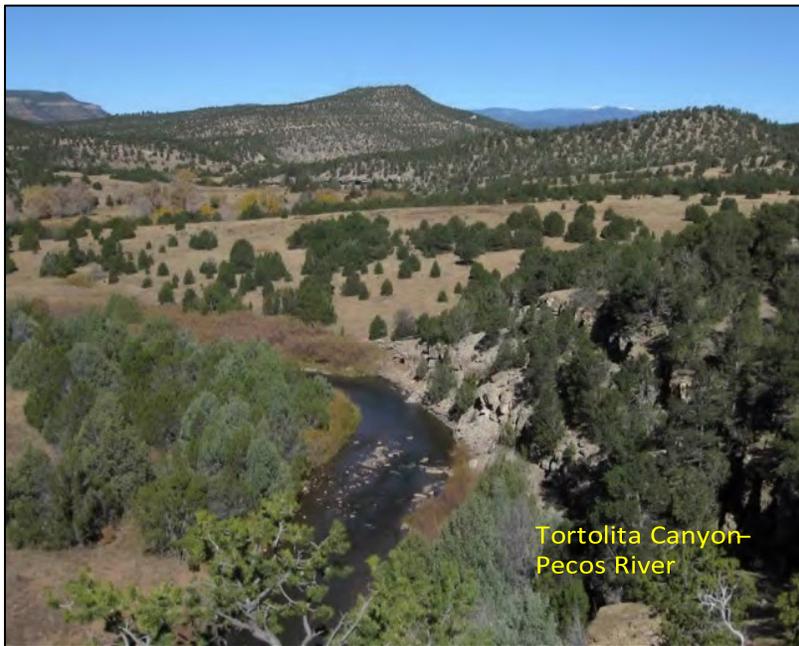
**2.8.7. Tortolita Canyon - Pecos River**

Area	38,367 ac.
Sedimentation category	99% Foothills; 1% Xeric
Principal perennial streams	Pecos River
Stream length, perennial streams	22.1
Principal vegetation classes	Grassland, piñon-juniper
Impairment status	Fully supporting
Restoration needs	Tree planting (for shade and seed) along Pecos River.

*The Tortolita Canyon sub-watershed is the lowest, or furthest downstream complete sub-watershed within the Upper Pecos watershed. Land cover is dominated by piñon-juniper scrub, grading into savanna, with some patches of grass and occasional Gambel oak woodlands. The Pecos River flows within a shallow sandstone canyon for most of this reach, and there are no perennial tributaries, as the sub-watershed boundaries coincide with the Glorieta Creek confluence at the upstream end and the Cow Creek confluence at the southern end. While there is healthy riparian vegetation along the Pecos River for most of this reach, it is largely coyote willow and herbaceous plants; there are few full-size trees near the stream bank – where present, they*

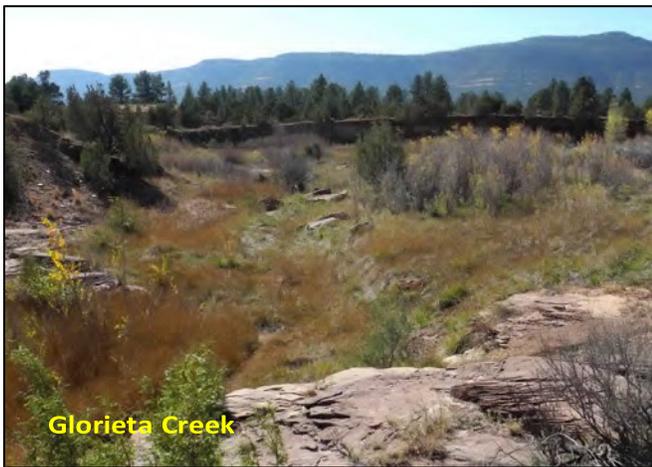
2.8.8. *Glorieta Creek*

Area	21,416 ac.
Sedimentation category	45% Mountain; 55% Foothills
Principal perennial streams	Glorieta Creek
Stream length, perennial streams	15.3
Principal vegetation classes	Grassland, piñon-juniper
Impairment status	Not supporting (standards under review)
Restoration needs	Conductivity investigation at Glorieta Creek.

*Vegetation in this sub-watershed is largely ponderosa in the upper reaches, with some mixed conifer on the northern slopes of the headwaters, and piñon-juniper in the lower half or so of the area. Glorieta Creek is listed as not attaining standards because of excessive conductivity below the Glorieta Conference Center wastewater treatment plant. The presence of the Conference Center, along with fairly dense (if rural) residential development that depends on septic tanks for liquid waste disposal, suggests a possible source for the dissolved material causing the conductivity; but additional investigation is needed to determine the actual source(s).*

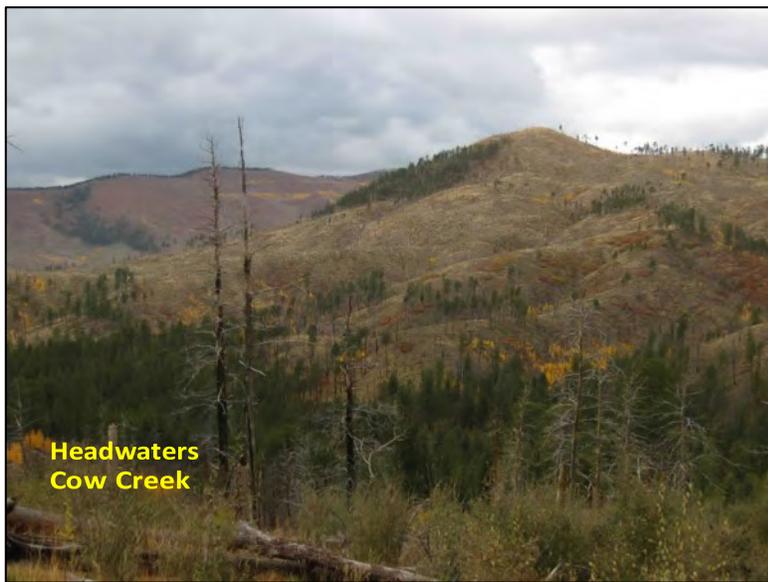
2.8.9. *Headwaters Cow Creek*

Area	27,622 ac.
Sedimentation category	100% Mountain
Principal perennial streams	Cow Creek, Soldier Creek, Elk Creek, Rito de la Osha, Rito Manzanares, Rito Torito
Stream length, perennial streams	36.4
Principal vegetation classes	Fire regeneration (includes grassland, Gambel oak, aspen, and conifer seedlings); mixed conifer
Impairment status	Not supporting
Restoration needs	Streamside vegetation; better runoff management; occasional stream narrowing; some natural stream channel restoration in areas of excessive erosion along roads etc.

*The majority of the Headwaters Cow Creek sub-watershed was affected by the Viveash fire of 2000 and the Tres Lagunas fire of 2013, and vegetation is classified as “Fire regeneration”, which includes primarily early-successional oak, aspen, conifer seedlings, and grasses. Areas not affected by the fire are mainly dominated by high-altitude mixed conifer forest, with some spruce-fir and subalpine meadow at the highest altitudes. Most of the sub-watershed is Forest Service land, but there are appreciable private inholdings totaling thousands of acres altogether. This entire reach of Cow Creek is listed as non-attaining because of excessive water temperatures, suggesting a need for additional streamside vegetation for shade,*

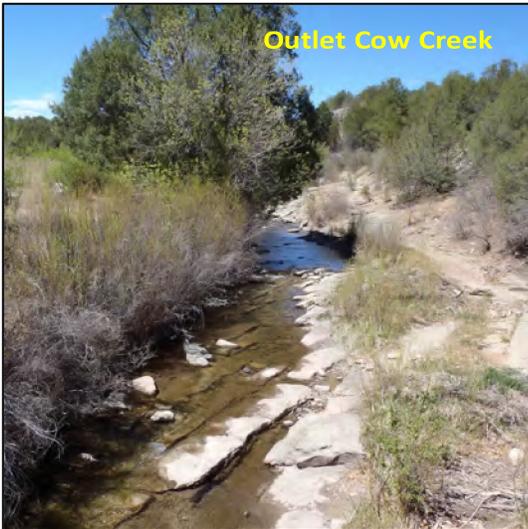
**2.8.10. Outlet Cow Creek**

Area	22,253 ac.
Sedimentation category	31% Mountain, 68% Foothills, 1% Xeric
Principal perennial streams	Cow Creek
Stream length, perennial streams	24.6
Principal vegetation classes	Gambel oak, piñon-juniper, ponderosa
Impairment status	Not supporting
Restoration needs

*Very little of this sub-watershed is accessible by road, and the majority is private land, making it very difficult to obtain direct information about watershed conditions. This reach of Cow Creek also fails to attain standards because of high temperatures, and examination of air photos suggests considerable opportunity for additional streamside vegetation, but actual riparian conditions could not be observed in the field for most of the reach. Site visits around the village of North San Ysidro identified a deeply incised channel and heavy sedimentation from agricultural runoff and riparian vegetation clearing by landowners. Stream restoration will be crucially dependent on collaboration with private landowners.*

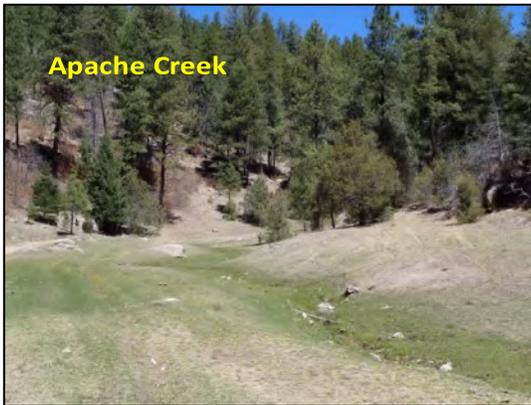
**2.8.12. Apache Creek**

Area	14,068 ac.
Sedimentation category	74% Mountain, 26% Foothills
Principal perennial streams	Apache Creek, Rito de la Vega
Stream length, perennial streams	May not be perennial
Principal vegetation classes	Piñon-juniper, ponderosa
Impairment status	Not assessed
Restoration needs	Streamside vegetation and grazing management; road erosion and runoff control

*Apache Creek was not assessed for attainment of water quality standards, and may not be perennial in all years. Its upper reaches were flowing when visited for this study, and there are meadows where cattle grazing appears to have prevented any trees or shrubs at all from becoming established along the stream, and cattle are contributing to damaged streambanks. There are also some road segments in need of culvert replacements and other erosion control.*

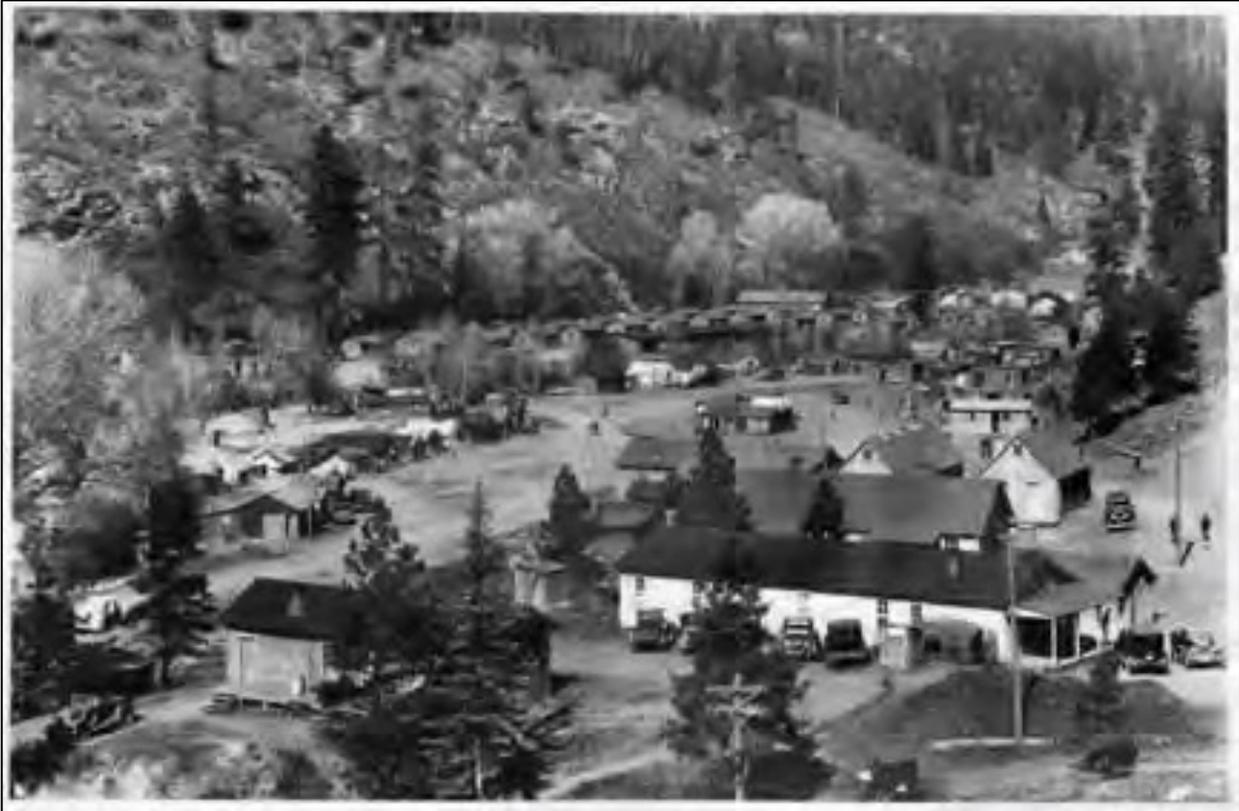
The Tererro mine (“Tererro” means mine dump in Spanish) operated at the confluence of Willow Creek and the Pecos River between 1882 and 1939. Mining activities were relatively small-scale from 1882 until 1925, when the American Metals Company took over the mine and expanded both mining and milling operations dramatically (see photographs on next page). Between 1926 and 1939, the mine produced approximately 2,200,000 tons of lead and zinc ore (Robinson 1995). Ore was transported aerial tram-cars to the mill in El

Molino (near the village of Pecos) for processing. Large amounts of mine tailings were disposed of at three sites, and some tailings at the mine site were dumped into the Pecos River.

In the 1950s, the State of New Mexico obtained the land where the mine and the mill had operated. Mine tailings were used for construction projects between the mine and the Village of Pecos. Additional roads projects, federal and state campgrounds, the Lisboa Springs Fish Hatchery, also utilized mine tailings in their construction. Mine tailings were also used by residents for an unknown number of undocumented construction projects.

In 1985 and 1986, the New Mexico Environment Department (NMED) began investigating contamination issues and concerns about water quality in the area raised by residents as these related to the Tererro mining operations. In 1991, contaminants carried into the Pecos River were responsible for a large-scale fish kill in the Pecos River below the mine site and at the Lisboa Springs hatchery. The local economy then suffered from a drop in tourism from concerns over the safety of the area. Additionally, two campgrounds were closed due to high levels of contaminants from the mine tailings used in their construction.

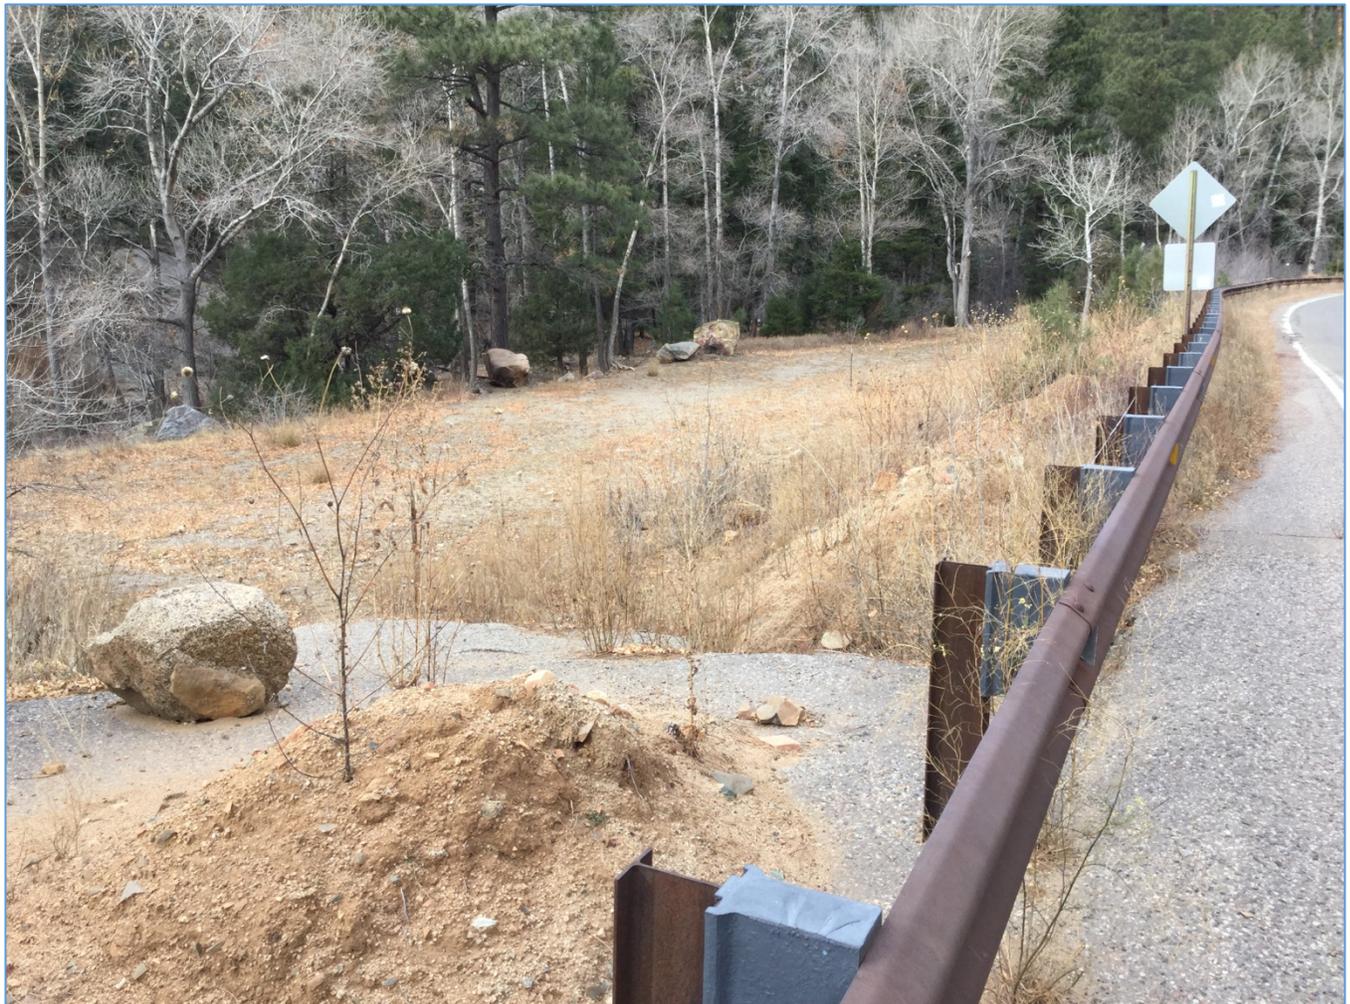
The NM Highway 63 guardrail project was one of UPWA’s first collaborative successes. It was undertaken by the New Mexico Department of Transportation (NMDOT) with input early-on from UPWA. This project, in addition to increasing safety along the highway, dramatically reduced off-road vehicle traffic up to the bank of the Pecos River. The photograph below shows an area between the highway and the river just upstream of Windy Bridge where the guardrail is allowing vegetation to recover after years of damage from vehicular traffic.

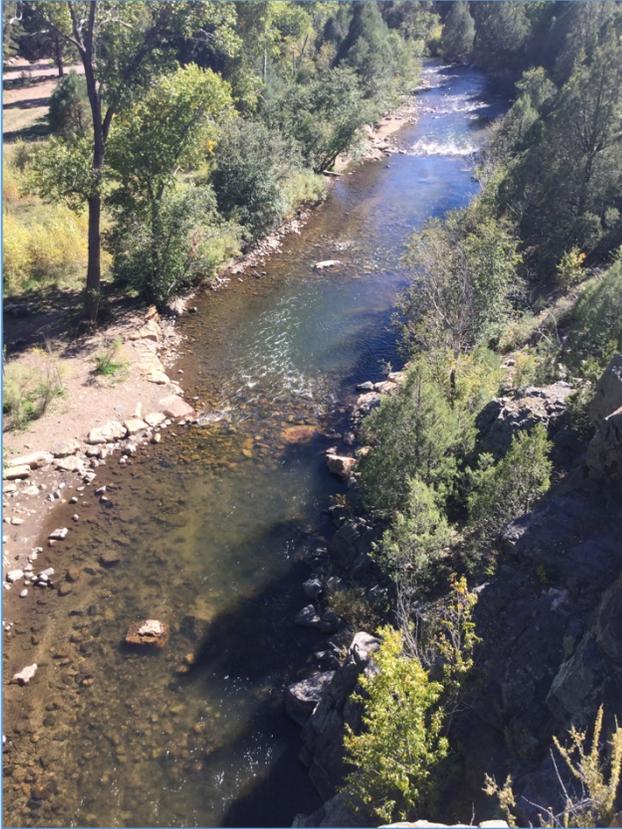
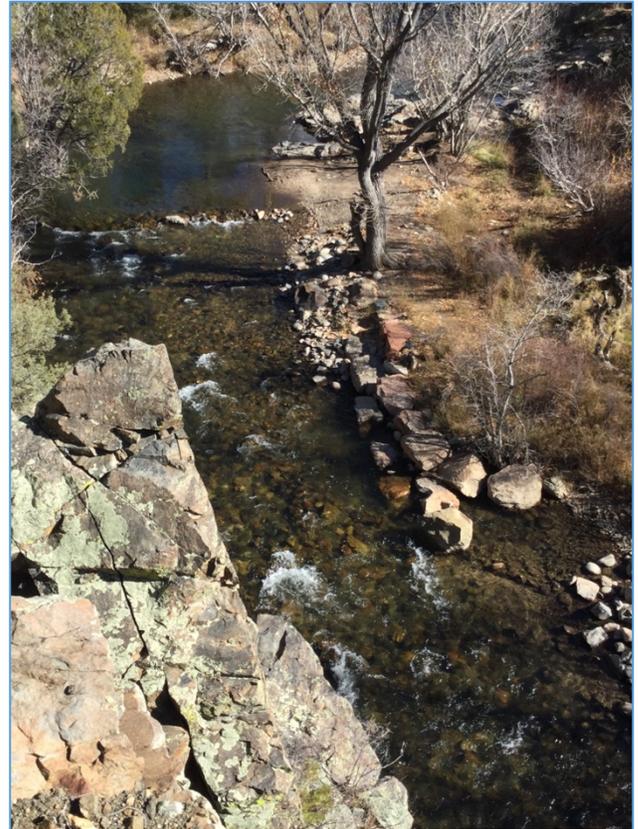
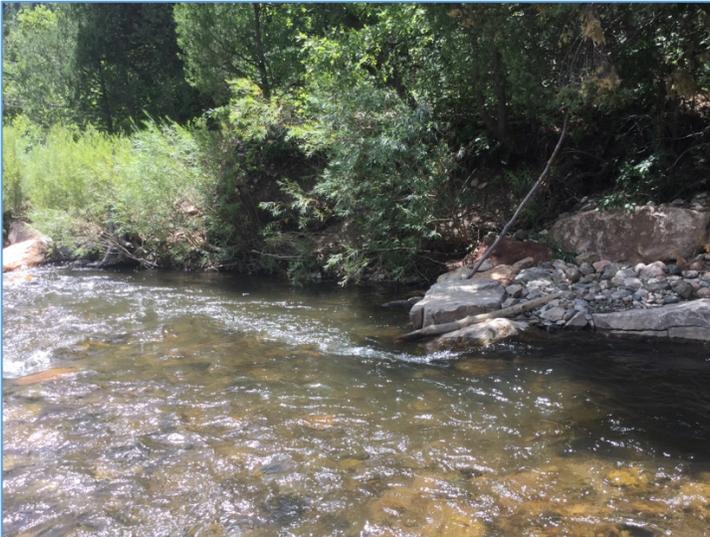
In the spring of 2016, UPWA used a River Stewardship Grant from the NMED to implement a restoration project at the Dalton Day Use Area in Pecos Canyon. Flooding after the Tres Lagunas fire had scoured the bank of the river through this reach and left the channel over-wide and shallow. The restoration project resulted in the excavation of a series of deep scour-pools protected by large boulders over a 1,300 foot reach of the river. The excavated riverbed material was deposited in the channel along the bank on river left to create gravel bars that narrow the channel and provide an opportunity for the natural revegetation of the bank. The project also removed an old rock gabion wall that was preventing the natural flow of floodwaters into the adjacent floodplain. Tree root-wads were buried in the floodplain to dissipate flow energy during future floods and along the bank on river right to redirect flow back to the middle of the channel. The following three photographs are of the Dalton Day Use Area project after construction.

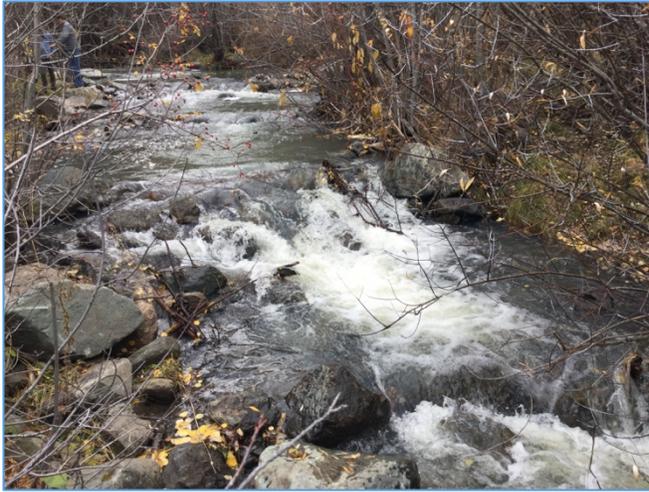
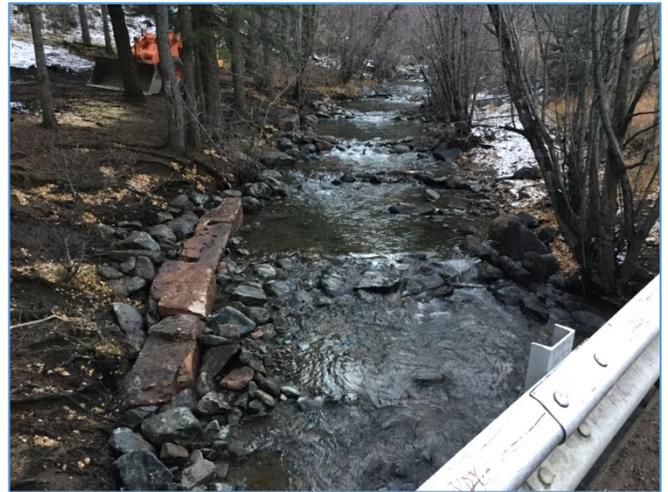
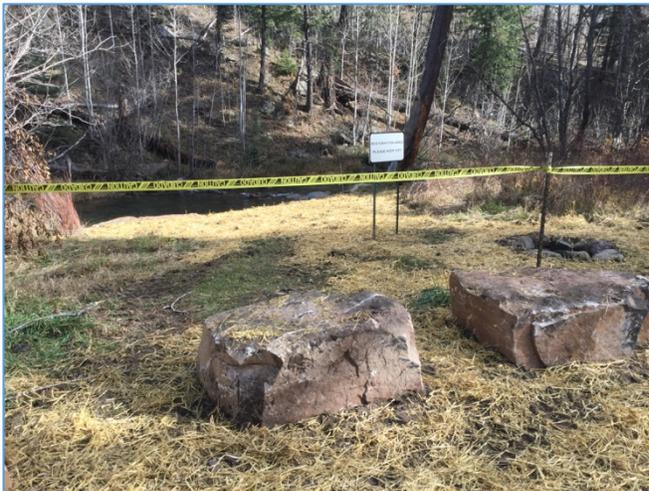
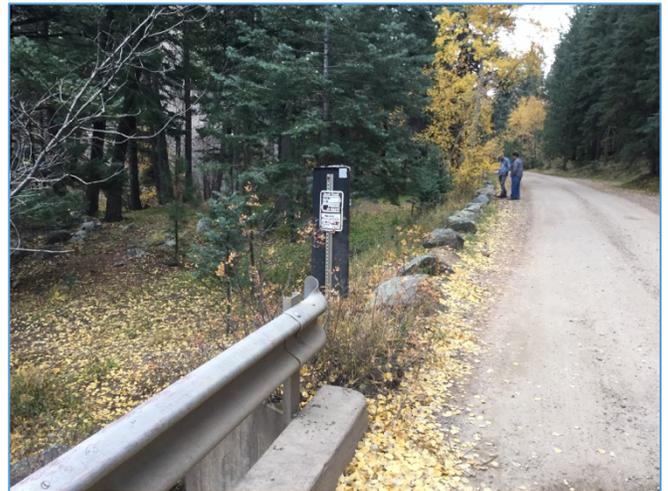
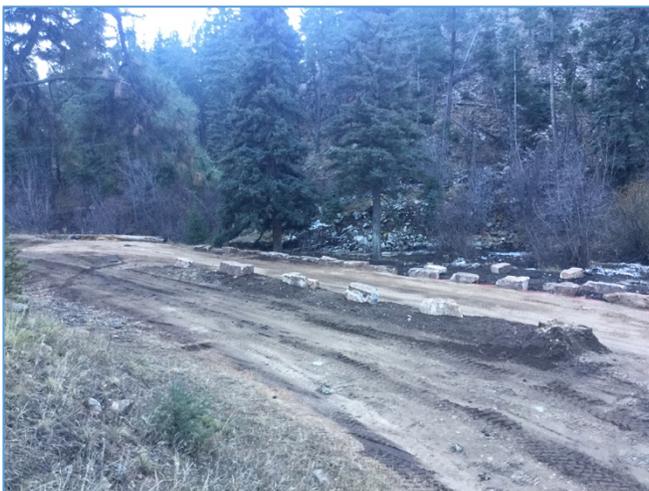
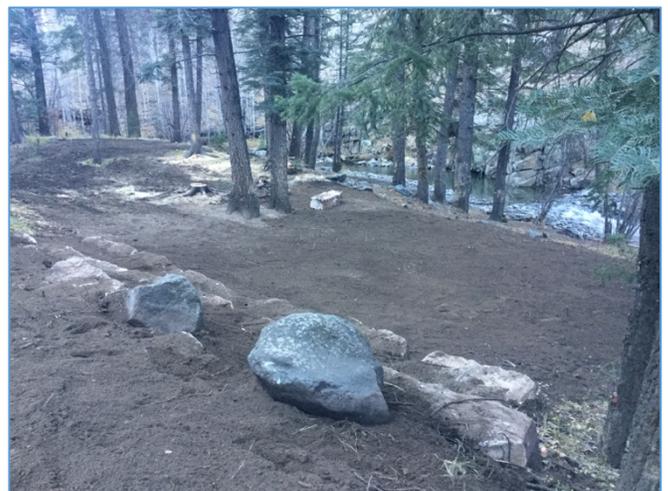
The Cow Creek Campgrounds project, called the Upper Cow Creek Habitat Restoration Project, was approved by the Santa Fe National Forest and implemented in fall of 2017. This project was conceived as a response to both the Viveash and Tres Lagunas fires. It was also designed to reduce off-road vehicular traffic at seven identified public access points along the creek. These access points were graded to slow down precipitation runoff, spread it out, and direct it away from the creek, so that more of it soaks into the ground and less sediment flows into the creek. Large boulders were placed along the side of the road to prevent vehicles from driving up into the access points and in some cases right up to the creek. Space was reserved by the side of the road for vehicles to pull off so that the public can still use these access points. In the creek, step pools were excavated to provide

refugia for fish and reduce solar heating in the summer. The following six photographs are from the Upper Cow Creek project area after construction.

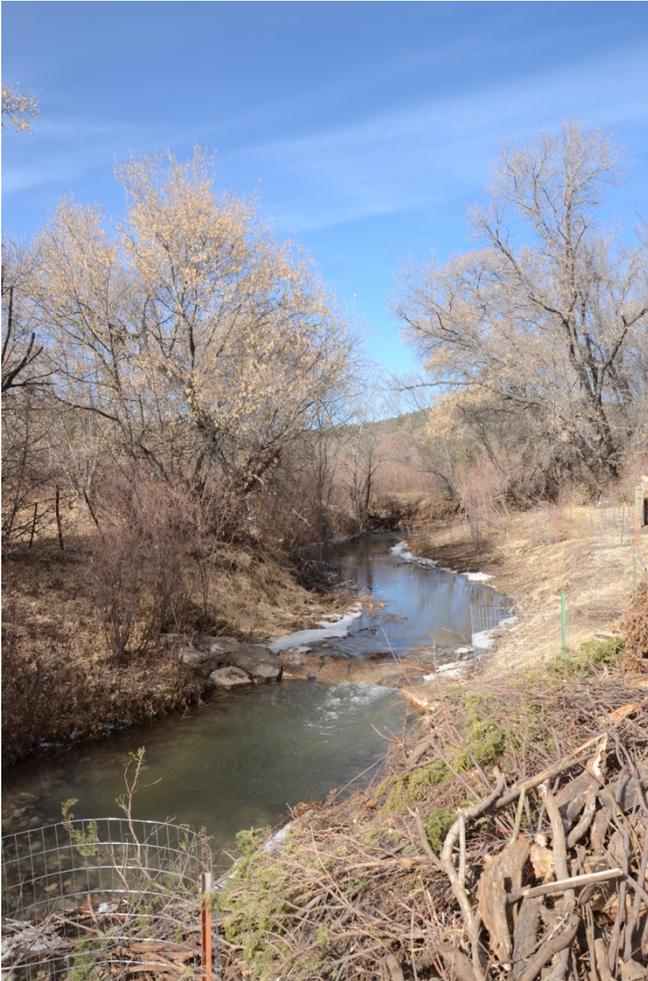
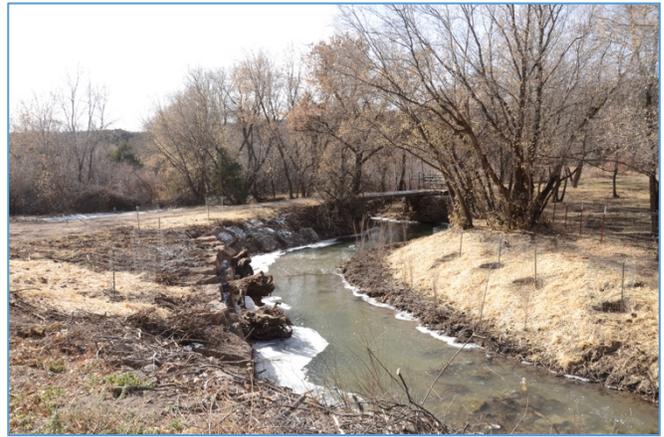
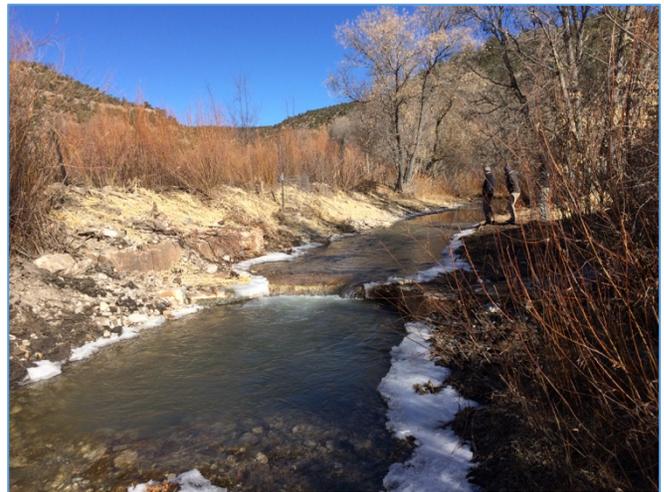
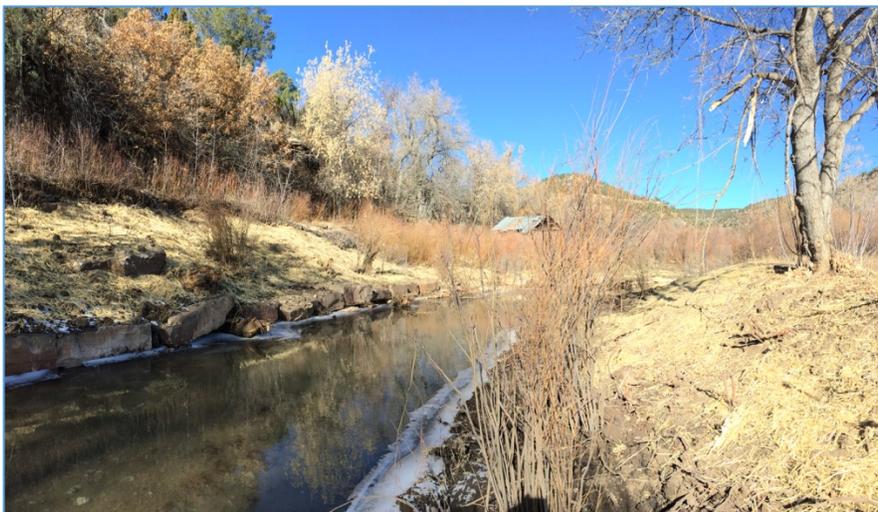
The most recently implemented project is on lower Cow Creek and is located just upstream from the village of North San Ysidro. Cow Creek in this location is deeply incised, over-wide in some areas, and subject to substantial sediment loading from adjacent lands where heavy grazing and tilling for agriculture take place. Bank

erosion in one location was threatening to undermine the local irrigation ditch and in another it was encroaching on the road where it had been redirected under a bridge. Scour pools, pools, and bank protection measures were installed along with willow transplants to address these issues with the goal of reducing sediment and water temperature. The following four photographs are of the lower Cow Creek project area after construction in November 2018.
